SMARTCOVER

SAN DIEGO SUBURB AVERTS MAJOR SEWER SPILL DURING STORMS

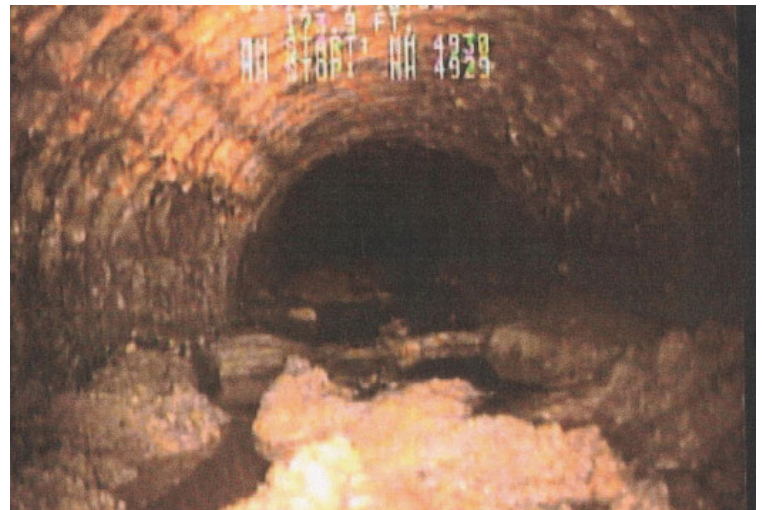
Camera work performed after the spill and prior to repair shows the extent of the collapse and the blockage caused by decaying concrete.

Repairs commenced immediately, thus avoiding a major spill, minimizing property damage and avoiding potentially millions of dollars in fines, lawsuits, and the prospect of more extensive repair and remediation costs.
